MERRIMACK RIVER BASIN
HARRISVILLE, NEW HAMPSHIRE

LAKE SKATUTAKEE DAM
NH 00066

PHASE I INSPECTION REPORT
NATIONAL DAM INSPECTION PROGRAM

MAY 1979

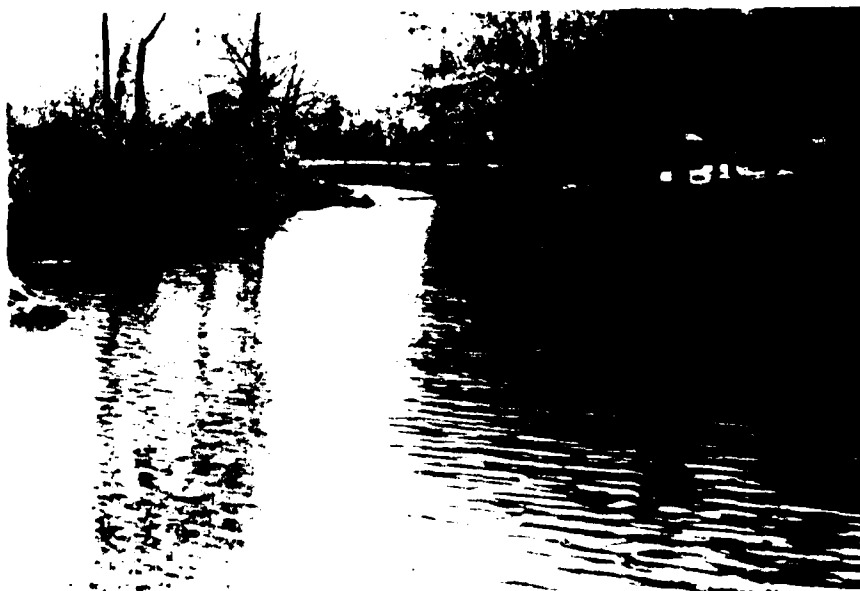
12. Lake Skatutakee northeast end near the channel with bridge, looking towards the "Lower Pond" downstream.

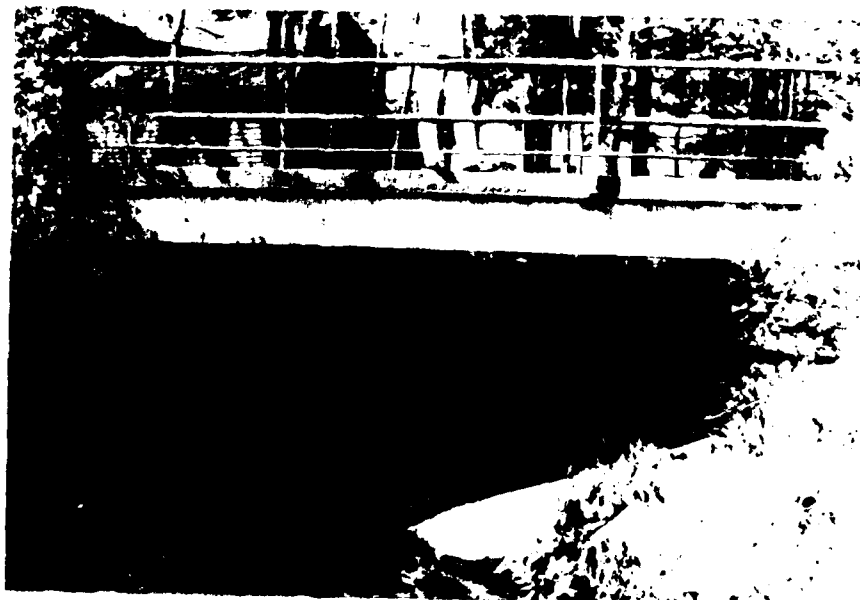
13. Bridge over the channel from the Lake Skatutakee to the "Lower Pond," looking upstream.

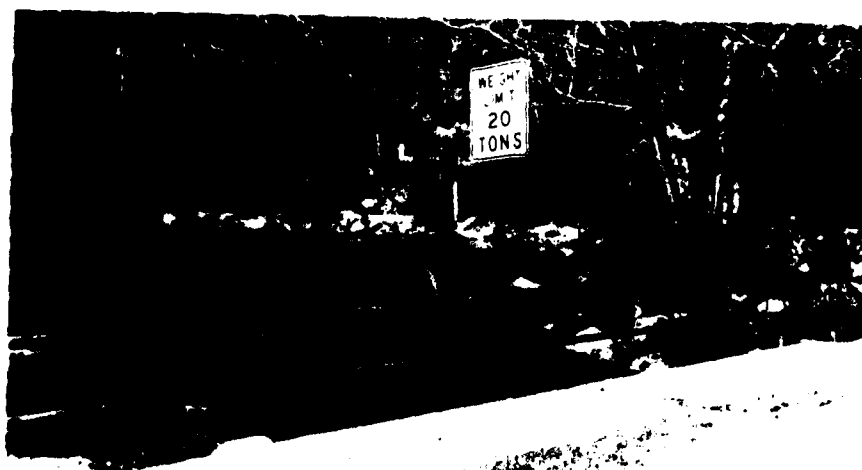
14. Same bridge, looking upstream (west) toward Lake Skatutakee.
